# **The Morphodynamics of Motunau Beach and Management Implications**

A thesis  
submitted in partial fulfilment  
of the requirements for the Degree of  
Master of Science in Geography  
at the  
University of Canterbury

**Department of Geography  
University of Canterbury  
Christchurch, 2009**

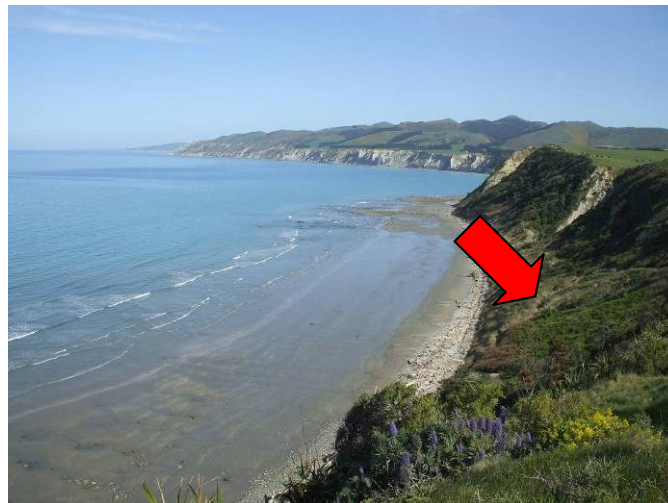
**Figure 6.8 Historic sand dune system on Sandy Bay which is currently experiencing erosion.**  
**Photograph taken looking west 17<sup>th</sup> September 2009.**

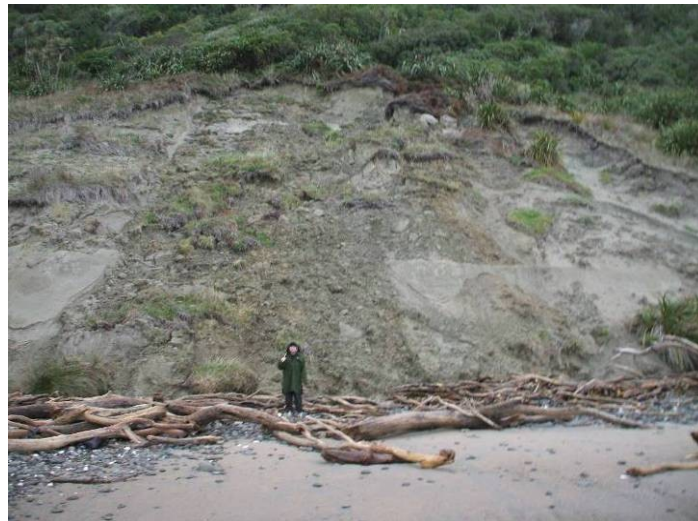
**Figure 6.11 Mass movement of the historical dune front at the western end of Sandy Bay. Note the lower level of protection to wave erosion offered by the thinner debris accumulation and gravel beach. Photograph taken early July 2009.**

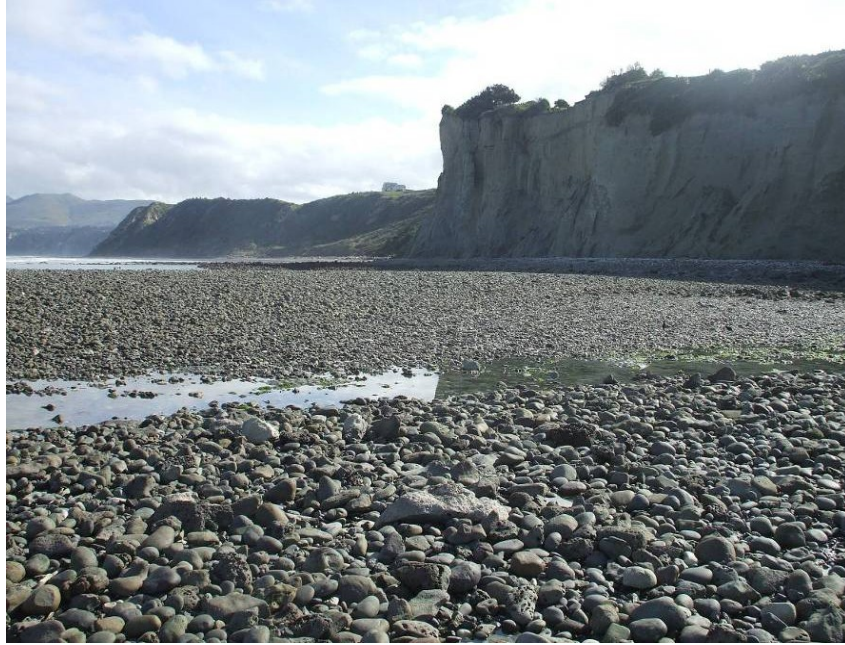
**Figure 6.14** The rockshore platform at the base of the eroding cliffs. Note the absence of fine sediments. Photograph taken looking west towards Sandy Bay 22<sup>nd</sup> August 09.

Given the orientation of the Motunau promontory it seems plausible that the process of littoral drift is complicated and less efficient as a result of the turbulent nearshore wave environment. Motunau Island presents a block in the path of the net northern transport direction. As a result, sediment bypassing of the nearshore zone could be occurring as sediment naturally adjusts in order to get around the Motunau promontory. The presence of the sediment-bare rockshore platforms suggests that at certain times of the year, when the wave climate is turbulent enough, this bypassing of sediment is occurring (Figure 6.14). Such a process of sediment bypassing is discussed by Storlazzi and Field (2000).

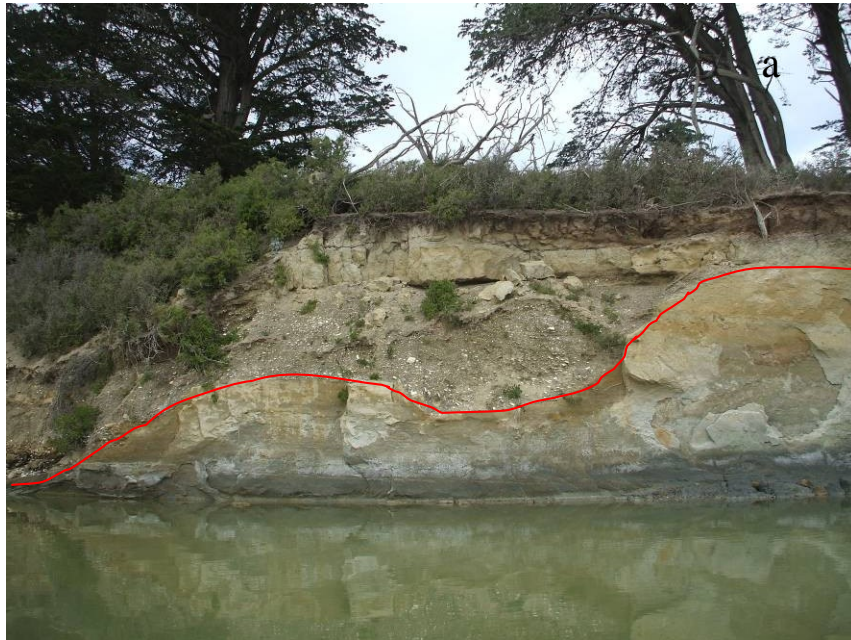
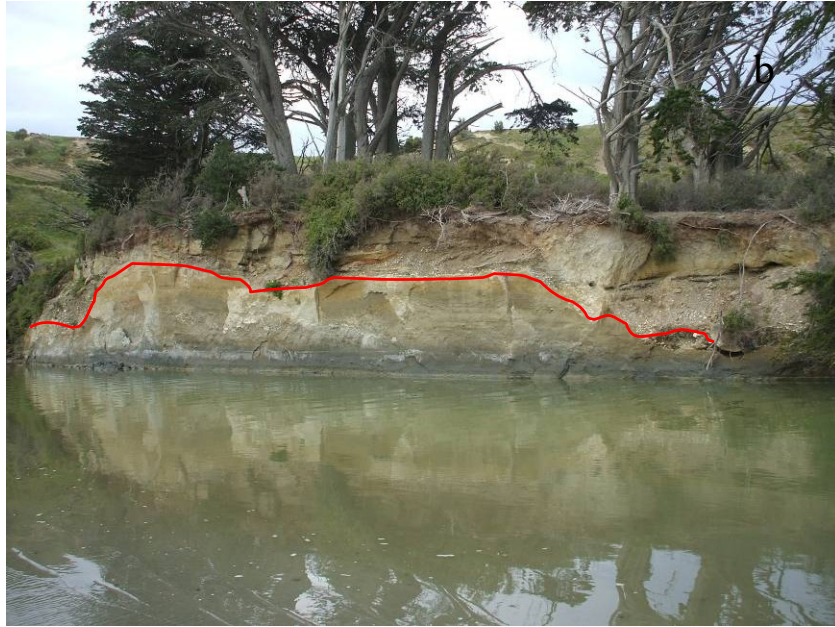
**Figure 6.15 Paleo-stream beds in the lower reaches of the Motunau River. Note the consolidated siltstones beneath the gravels associated with river deposits. The red lines indicate the unconformity associated with river channel incision. These indicate old river flow paths prior to its current position. Photographs taken July 2009.**

in the current river bank. The river has been through phases of increased incision as the promontory has been uplifted at rates of  $1.5$  to  $1.7 \text{ mm yr}^{-1}$  (R.W. Morris and Associates, 1987), and as sea levels have risen and fallen (Figure 6.15). As the river has naturally adjusted to flow regimes and sea levels throughout the current post-glacial era, a sequence of paleo river beds have been produced and the river has avulsed to its current position which faces south-southwest.

During high-energy river flow events it appears that the slope and area of the Motunau River channel increase, the general grain size becomes coarser, and the increase in channel roughness means that the flow becomes more turbulent. As fines are washed away, coarsening of sediments occurs, and the channel is less responsive to change as the coarser sediments are less easily removed from the channel bed. This process appears to have occurred in August 2008 and is one explanation for the low level of adjustments recorded in this 2009 study period. The hydraulics of the river becomes more influenced by the coarser grains. This ultimately means that to accommodate for the increased volume of water, channel form adjusts to find the most efficient route out to sea (Wilkinson et al., 2008). It is possible that these sporadic large-scale river flows in the Motunau River are the cause of the changing bed positions over the current post-glacial period, as depicted in Figure 6.15.

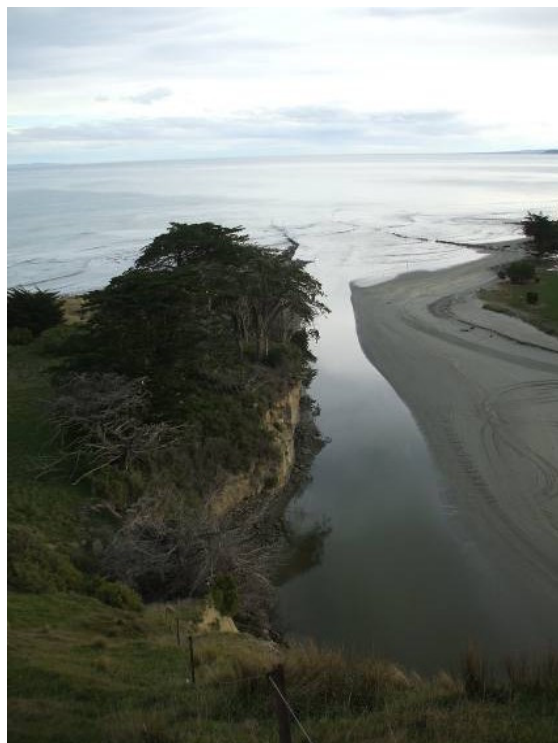
**Figure 6.16** View looking SW towards the Motunau River mouth. Note the variable widths across the length of the lower reaches. Photograph taken 2008.

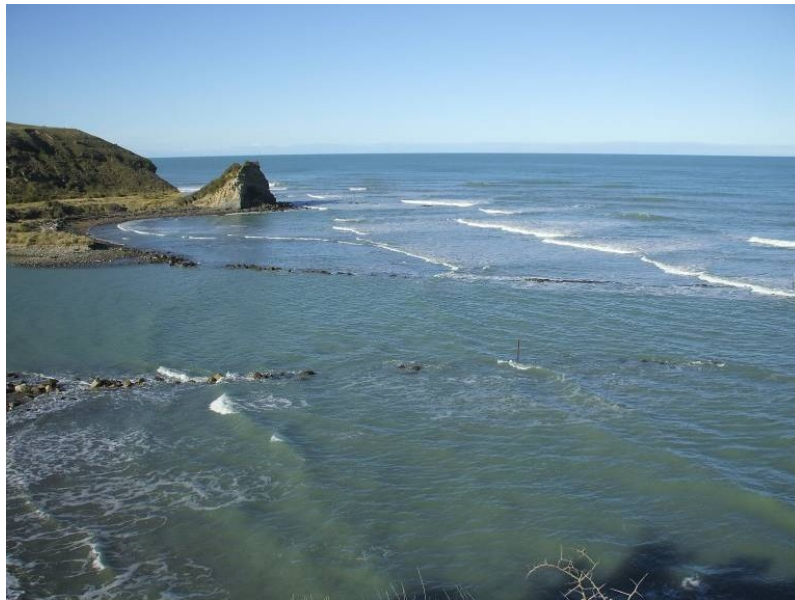
**Figure 6.17 Inundation of the channel guides at the mouth of the Motunau River during high tide. Late June 2009.**

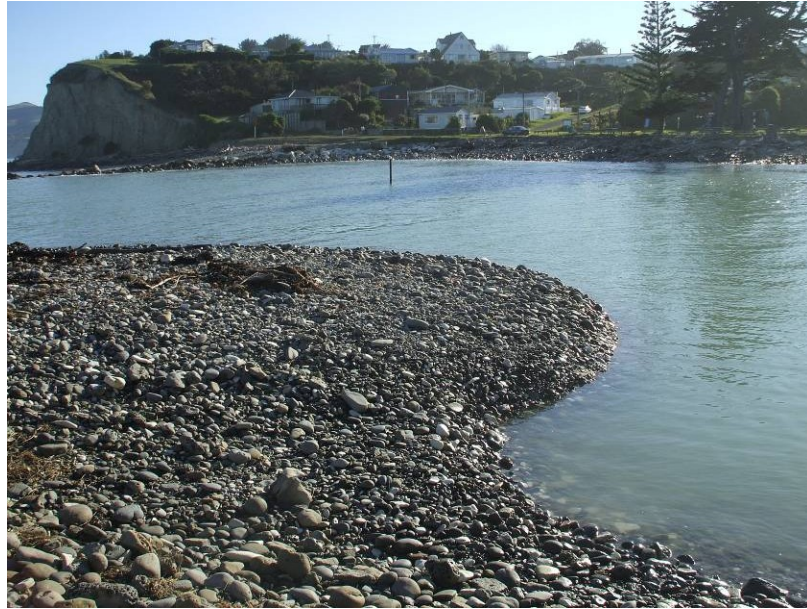
**Figure 6.18 Deposition and formation of a swash bar in the channel of the Motunau River is evidence the channel guides are doing little in way of distribution of sediment out of the channel. This swash bar confirms the wave dominance at the river mouth (18<sup>th</sup> June 2009).**

In early July deposition of a swash bar formation began to occur in the mouth of the river. This had obvious implications for the safety of fishing vessels and the access to and from the river (Figure 6.18). It appeared this deposition occurred due to the erosion of the river bank on the seaward side of the river mouth, allowing wave energy to penetrate during high tides and deposit material (Figure 6.19). In response to this problem the swash bar deposit was excavated from the river channel and used to reinforce the bank (Figure 6.20). This however proved to be a temporary solution as the bank continued to erode and material was re-deposited back into the river mouth.

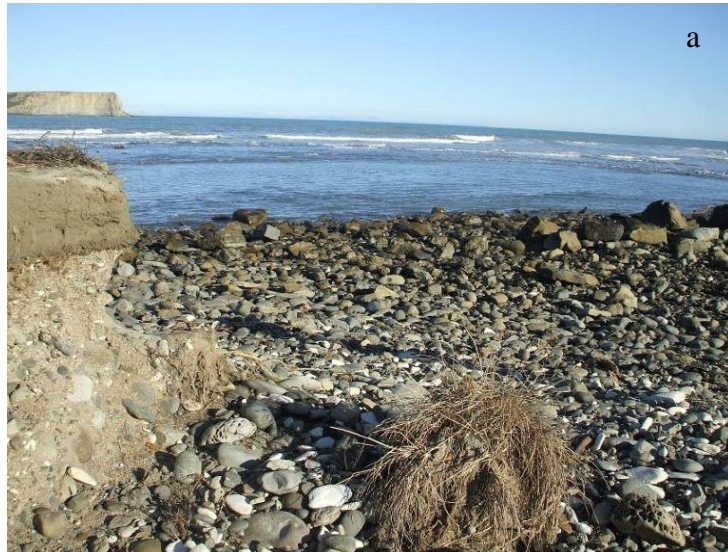
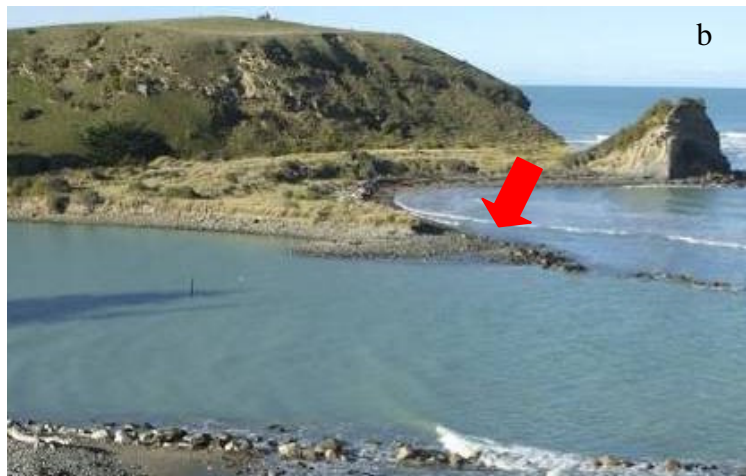
**Figure 6.19 Erosion of the seaward river bank. a) A gap emerged in the bank between the sea and the river channel. b) Location of the breach on the seaward side of river mouth. 18<sup>th</sup> June 2009.**

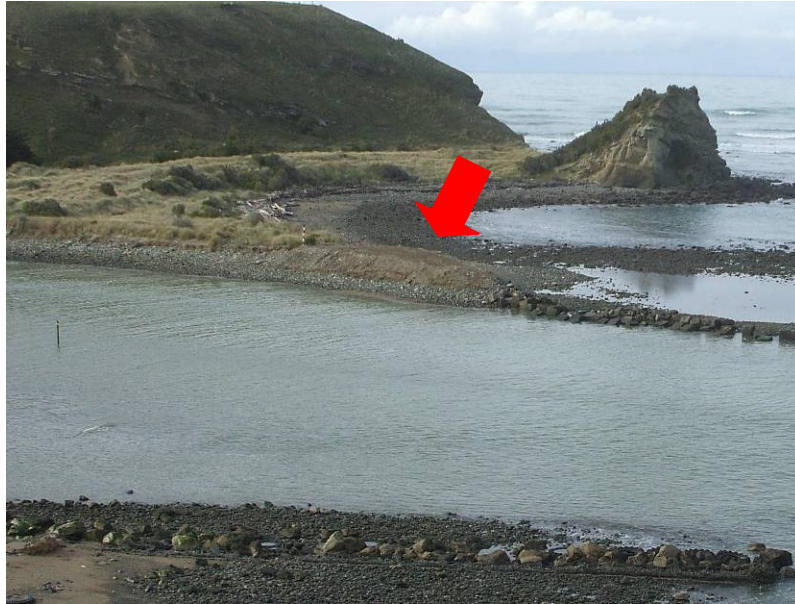
**Figure 6.20** Excavated material from the river channel used to reinforce the bank. 13<sup>th</sup> July 2009.

This highlights the short-term nature of the link between human interventions and coastal processes along the promontory. In comparison to the longer-term processes of coastal change human interference in the river mouth area appears to have done very little.

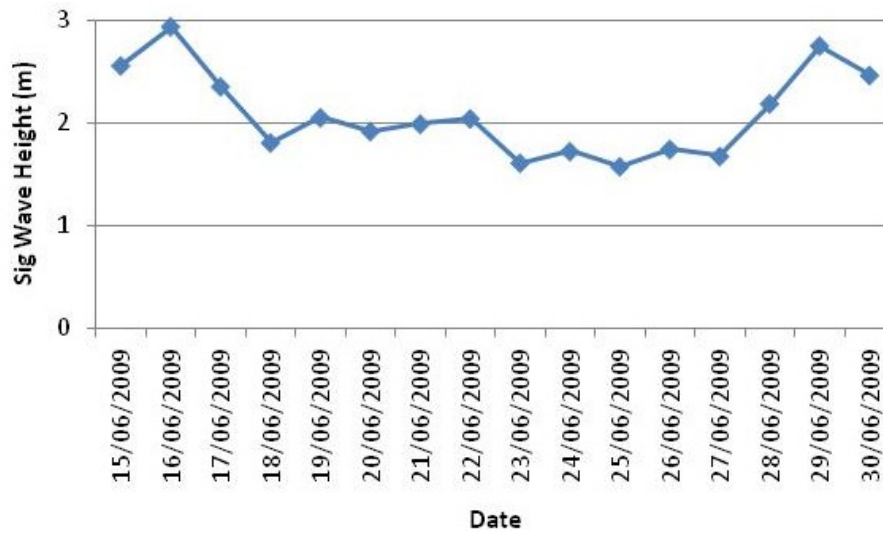
# **Appendix I: Significant wave heights for the two week periods between field visits**

most frequently occurring wave direction is from the south with an average wave height of 2.09 m.
